CASE STUDY

Scott's Point rock fillets – fish friendly erosion mitigation

Authors: Charlotte Jenkins, Kylie Russell, NSW Department of Primary Industries (Fisheries)

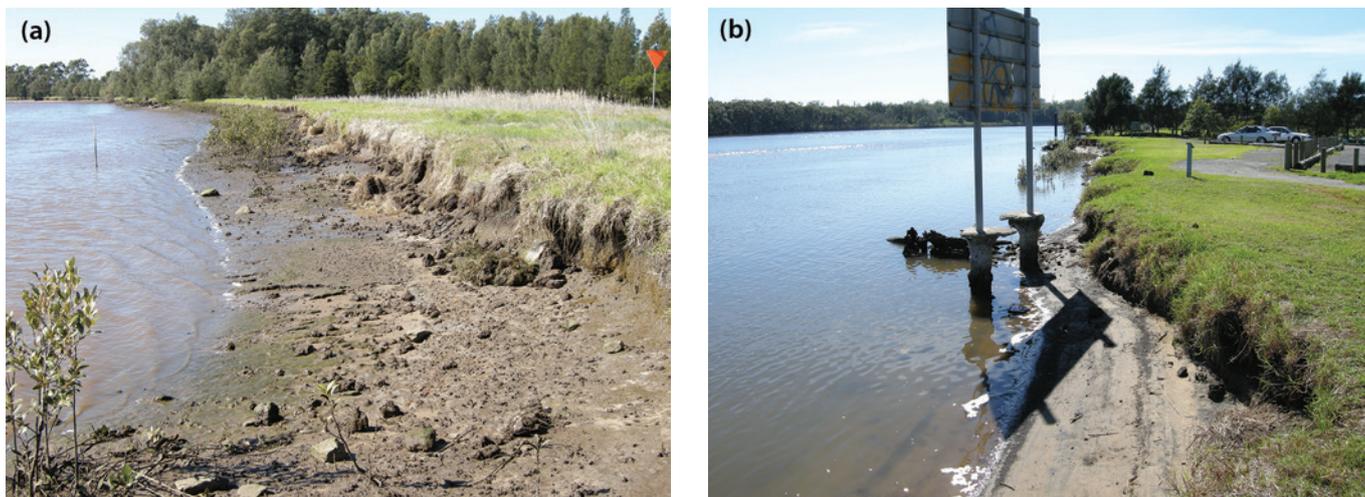
Excessive bank erosion damages the near shore environment, can have long-term impacts on downstream aquatic habitat and degrades water quality through increased turbidity and sedimentation. Continual pressure from erosive wind wave wash, fluvial and tidal processes as well as anthropogenic impacts such as excessive boat wash from recreational boating and denuded riparian zones resulted in an ongoing loss of alluvial soils at Scott's Point. Bank erosion was threatening infrastructure including an access road, navigation signs and power lines (Figure 2).

Figure 2. a) and b) Depicting bank erosion at Scotts Point.

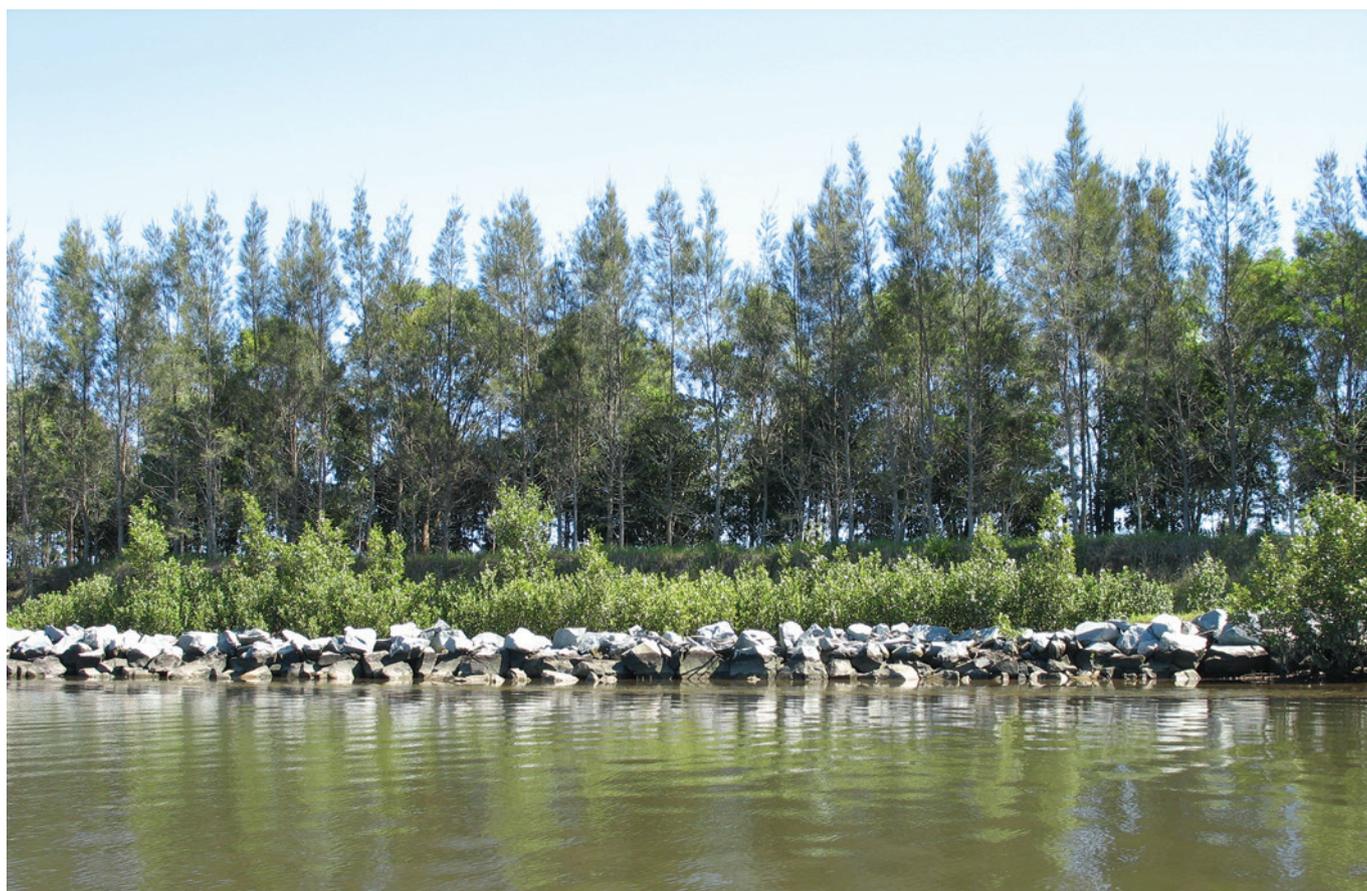
Figure 3. Rock fillet erosion control at Dumaresq Island, Manning Estuary showing supported mangrove growth.

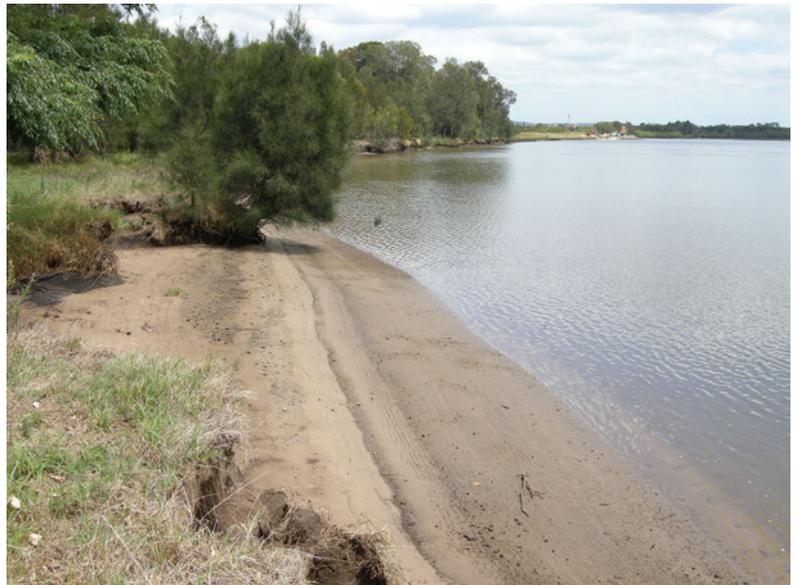
Figure 7. a) Photo point 10, highly undercut eroding bank before works, 2011.

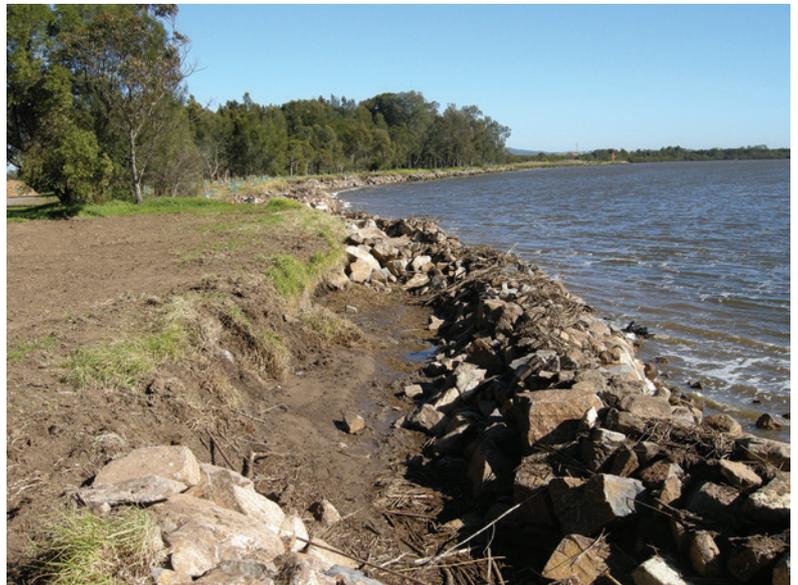
b) Photo point 10 post works, July 2011.

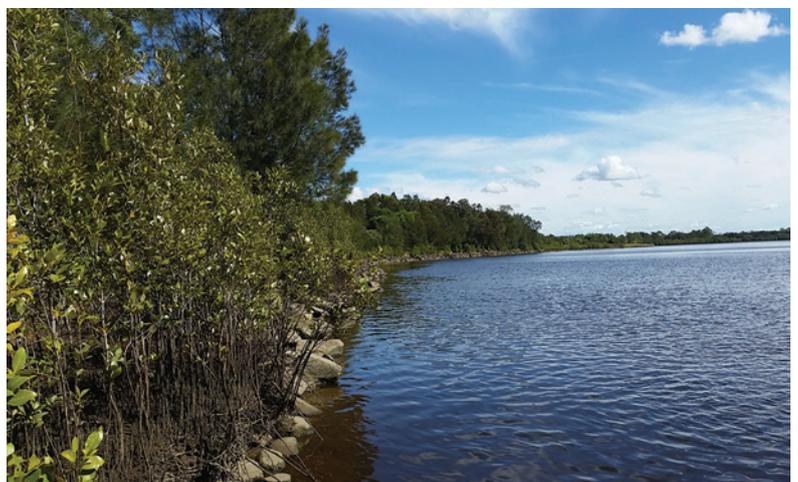
c) Photo point 10 with mangrove recruitment, deep sediment accretion and established riparian vegetation, April 2017.

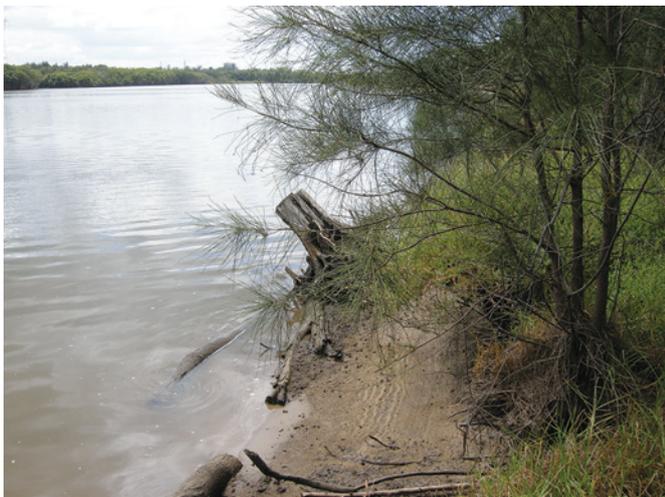
Figure 8. a) Photo point 7, undercut banks, failing riparian vegetation before works, 2011.

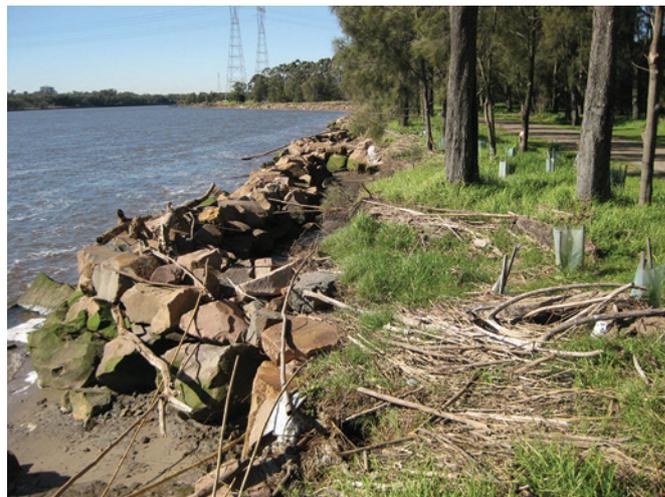
b) Photo point 7 post works with minor flood wrack, July 2011.

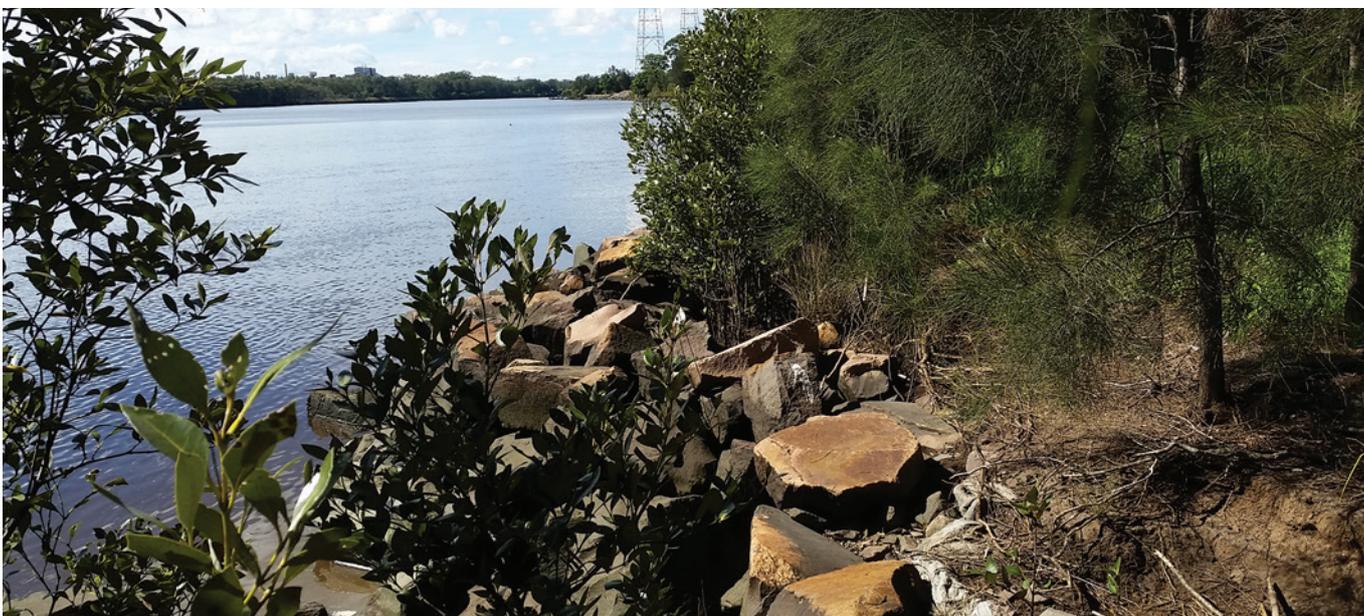
c) Photo point 7 with mangrove recruitment, deep sediment accretion and established riparian vegetation, April 2017.

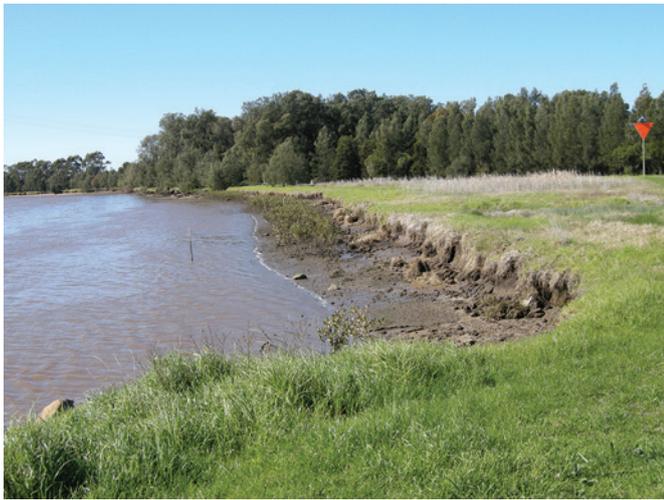
Figure 9. a) Photo point 4 before works March 2010, vertical banks and at risk mangrove recruitment.

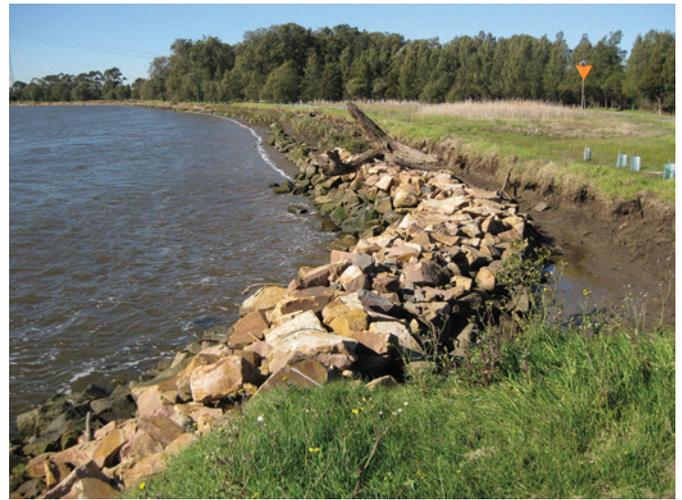
b) Photo point 4 post works July 2011, showing full scale rock fillet in foreground, low fillets beyond.

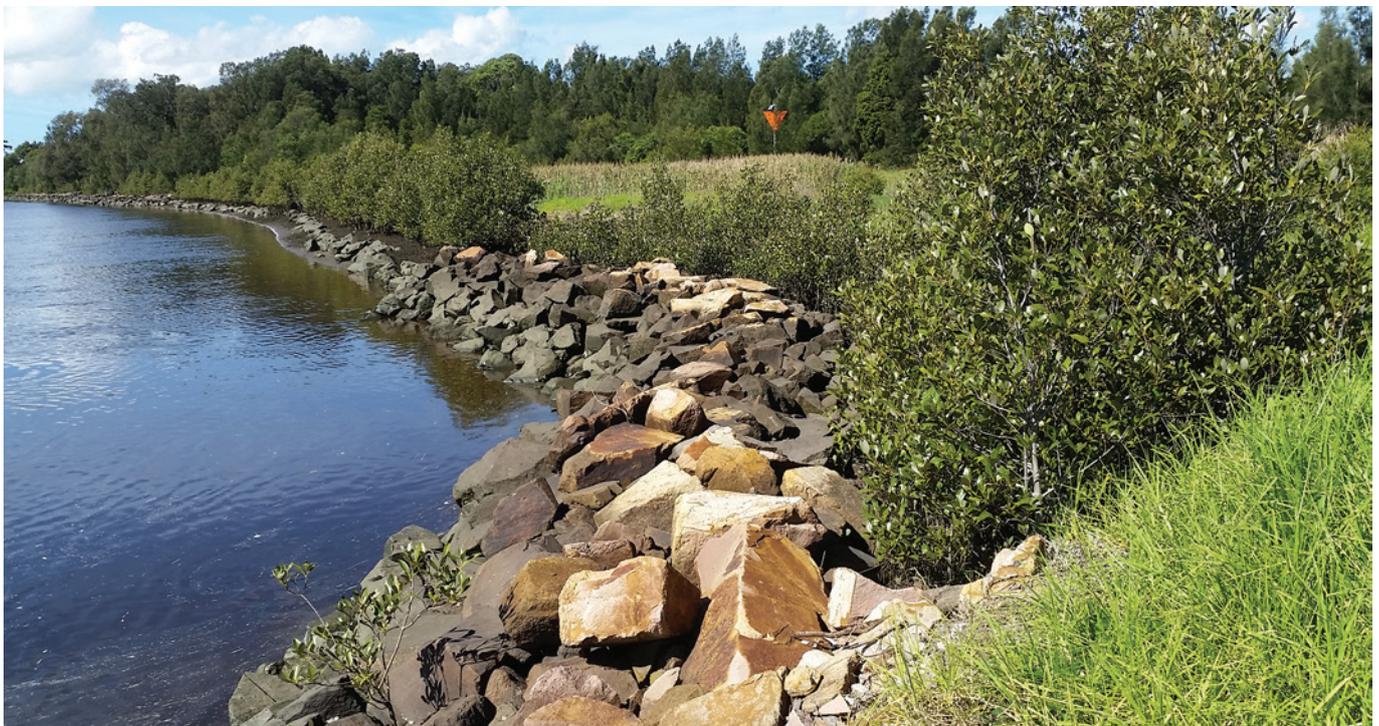
c) Photo point 4 with mangrove recruitment and stabilised bank, April 2017.

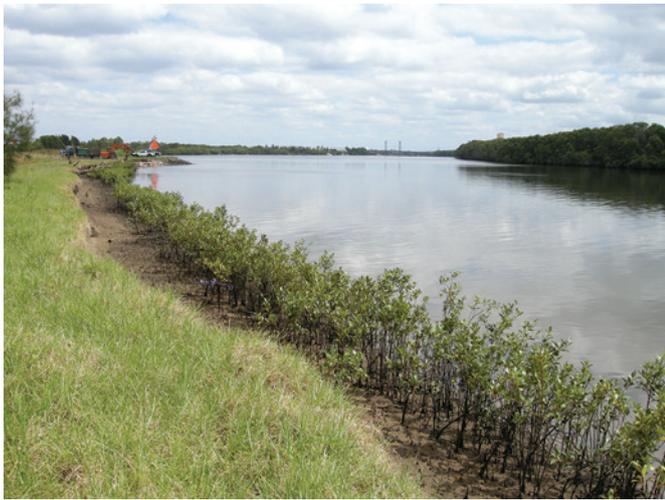
Figure 10. a) Photo point 5 at risk juvenile mangroves, low fillet area before works, March 2010.

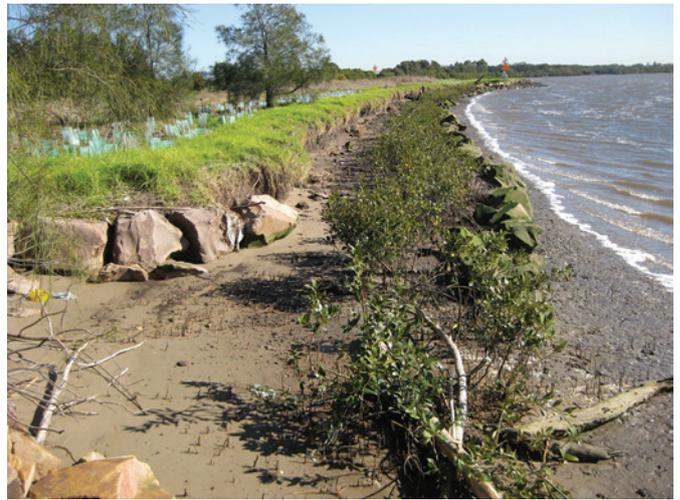
b) Photo point 5 juvenile mangrove low fillet area post works, July 2011.

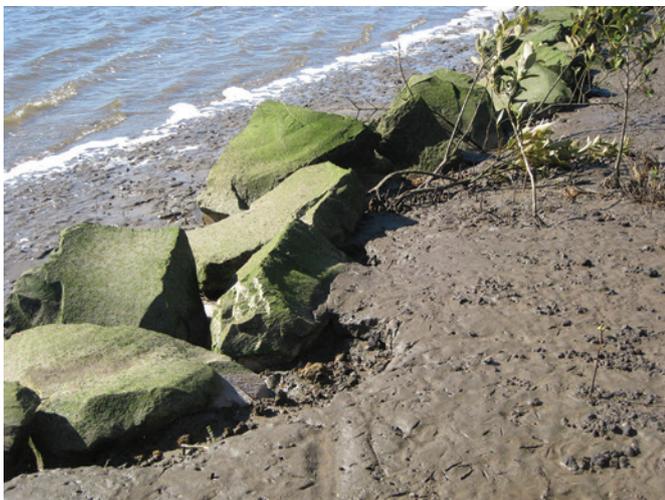
The mid-construction flood deposited a noticeable layer of sediment behind the rockwork, and was very successful at covering the exposed roots of juvenile mangroves protected by low fillets (Figure 10c). Some rill erosion occurred at gaps between the low fillet rocks and it may be advisable to use either more smaller rocks during construction, fill in the gaps between larger rocks using smaller ones by hand or place two rows of rocks. Overall, this lower fillet technique worked very well at protecting established juvenile mangroves at a significantly reduced cost to full size rock fillets.

c) Sediment deposition and minor rill erosion at low fillets following minor flood.

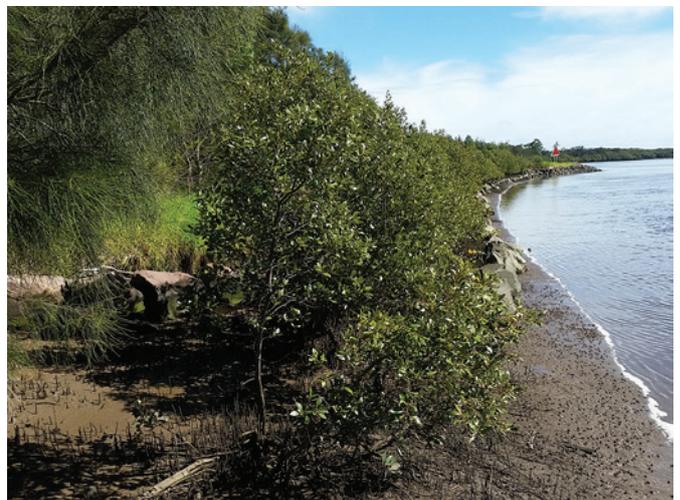
d) Photo point 5 juvenile mangrove low fillet area with mangrove recruitment and stabilised bank, April 2017.
