ESTUARY MANAGEMENT PROGRAM CASE STUDY

Rowland Reserve foreshore stabilisation

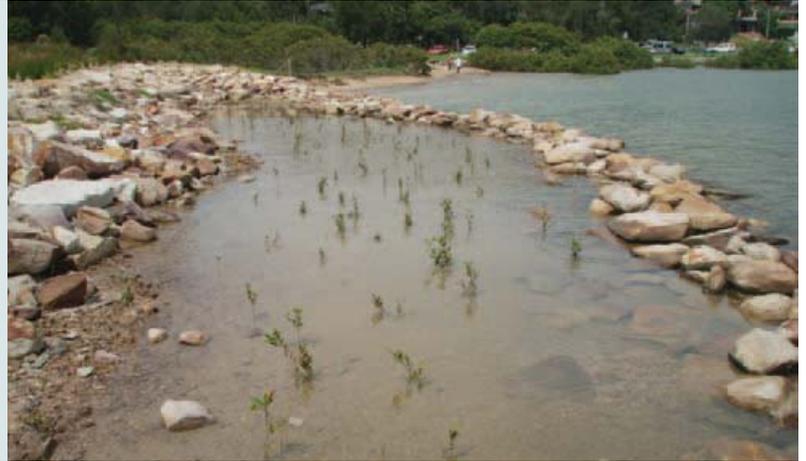
Figure 1: Part of the completed seawall with a bench of planted mangroves.

Pittwater Council has constructed an environmentally friendly seawall (Figure 1) to control erosion along a popular foreshore reserve with the assistance of \$145,000 from the Estuary Management Program.

Completed works have halted the loss of foreshore and increased valuable estuarine habitat, while improving public access and safety.

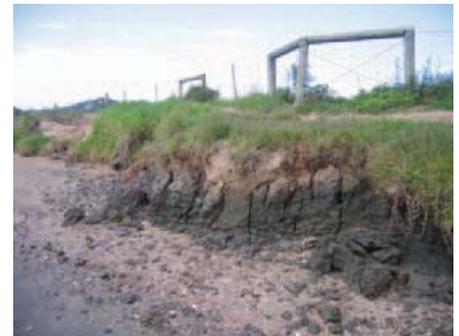
The northern edge of Rowland Reserve, located at Bayview in Pittwater, had a well known ongoing erosion and sedimentation problem. The Pittwater Estuary Processes Study (Lawson and Treloar, 2003) and Pittwater Estuary Management Study (WBM, 2006) had it earmarked as a high priority erosion site for rehabilitation. The eroded sediment was a potential threat to existing seagrass beds through smothering and increased turbidity. The continual erosion was also resulting in loss of foreshore area and public recreation space. Prior to the works, the northern edge consisted of a dangerous steep collapsing scarp with a 1.2m dune fence on the high side (Figure 2).

Figure 2: Erosion escarpment prior to rehabilitation works.

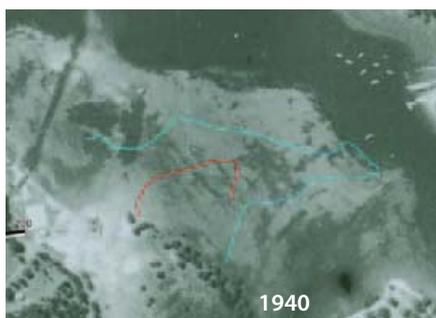
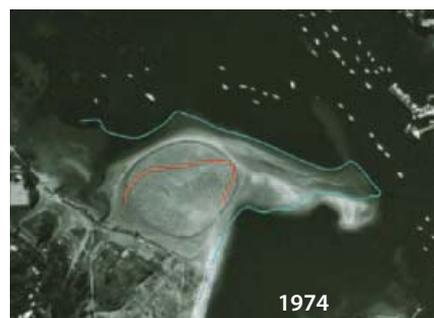
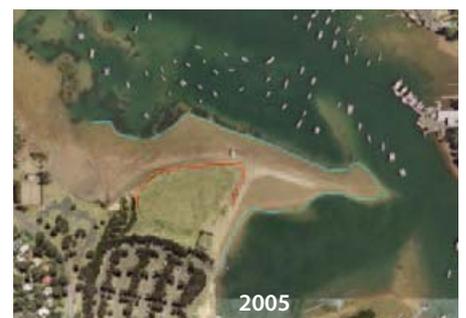
Over the years Rowland Reserve has changed dramatically from its natural state of intertidal flats, due to large scale dredging and reclamation which started around 1940 (Figure 3). The current reserve was formed somewhere between 1970 and 1974 through reclamation and since then the northern margin has been eroding at nearly 1m a year from wave action.

Figure 3: Historical aerial photos show the changes from intertidal flats in 1940 to the reclaimed reserve in 1974, and reserve alignment in 2005, after a recession of around 20m. The red line shows the position of 2005 erosion escarpment and the blue line shows the 2005 tidal flat dropover. (Photos: OEH)

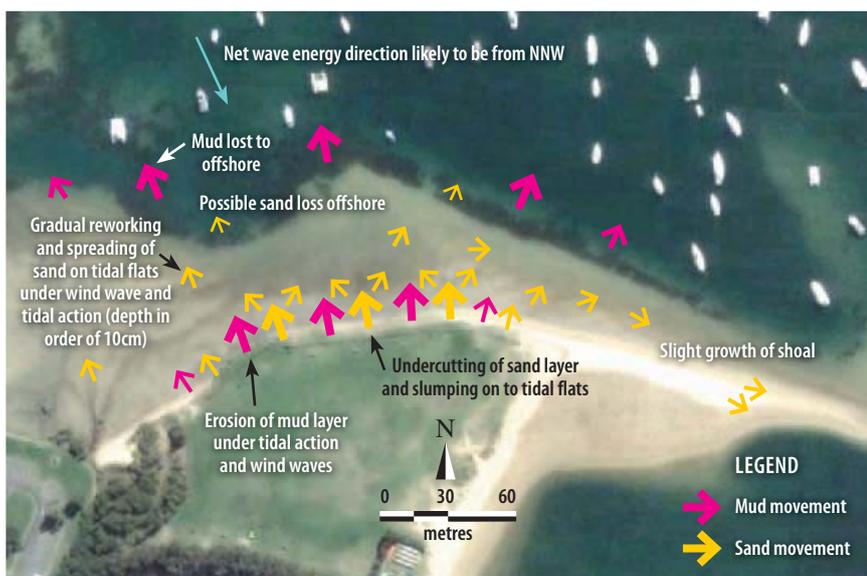
Anecdotal evidence had suggested that the recession at Rowland Reserve was mainly due to longshore drift and movement of sand east to form the spit. However, analysis of the photogrammetry and hydro-surveys revealed that the spit had not grown noticeably or had any perceivable shallowing of the surrounding channels.

Figure 4: Conceptual model of sediment transport processes at Rowland Reserve (Worley Parsons, 2008).

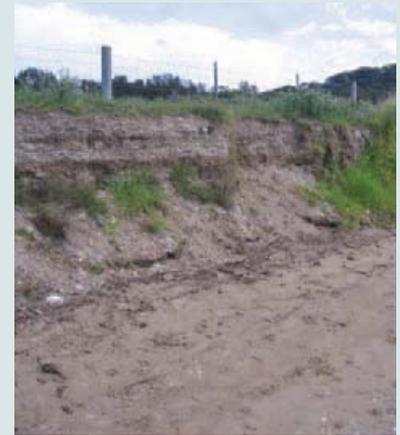
The erosion was a result of the reclaimed land being out of equilibrium with the prevailing wind-wave climate, resulting in waves (up to 1m) undercutting the base of the bank, leading to collapse of the upper sandy soil from the steep lower mud profile (Figure 5). The erosion was expected to continue until the cross shore profile was in equilibrium with the prevailing wind-wave climate. Eventually this would have resulted in a foreshore with a very flat slope, similar to the original tidal flats prior to reclamation, as well as the loss of popular foreshore parkland.

Figure 5: Erosion escarpment showing collapse of upper sandy soil.

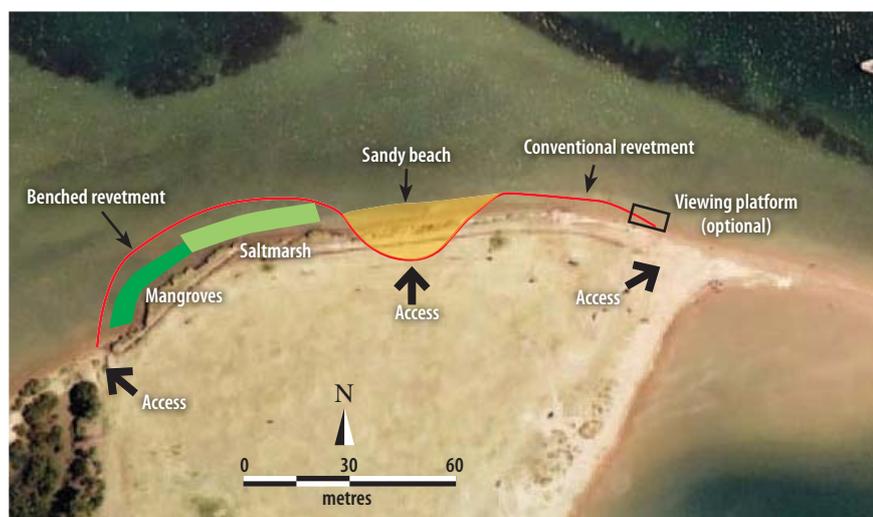
Figure 6: Preferred design implemented by council. (Photo: Worley Parsons, 2008)

The final design favoured by council and the community (Figure 6) entailed a constructed benched rock seawall (revetment) with mangroves and saltmarsh in separate bays at the western end, a designated beach area for foreshore access, and a conventional rock seawall at the eastern end. This provides a range of environmental and recreational opportunities and helped to keep costs down. The seawall was backed by plantings of native riparian species to maximise environmental outcomes. This project has balanced the need to expand surrounding vegetation communities with minimising the impacts on views. This was achieved by having mangroves at the western point only, where they already existed. Low-lying riparian species were also planted along the whole foreshore for unobstructed views. This follows recommended design principles outlined in the *Environmentally Friendly Seawall Guidelines* (DECC and SMCMA, 2009).

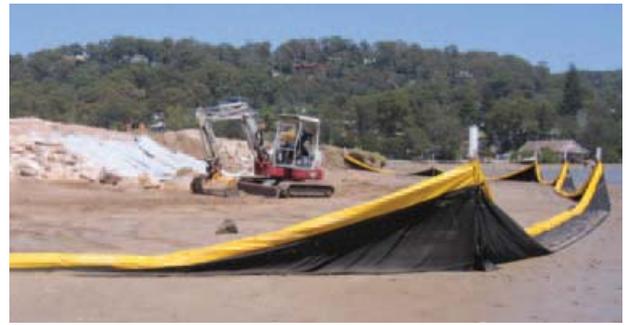
Figure 7: Use of geotextile fabric behind the boulders and sediment control barriers during construction.

- Around 2500 tonnes of sandstone boulders used, predominantly sourced from local excavation sites. Boulders were underlain with geotextile fabric to control loss of fine material (Figure 7).

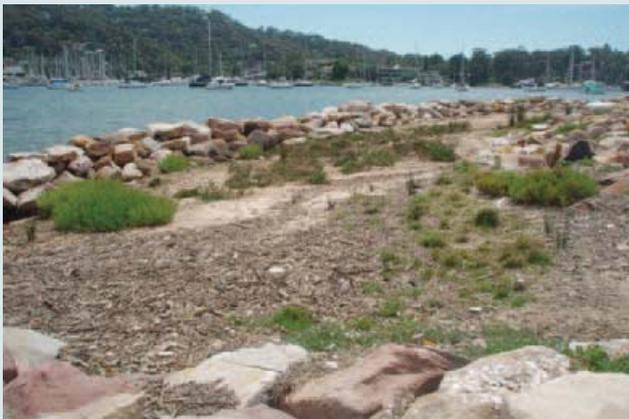
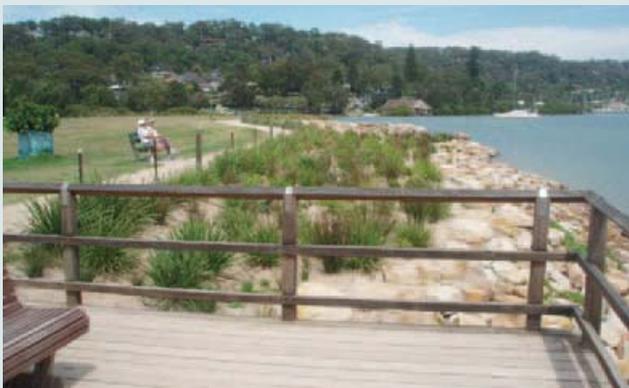
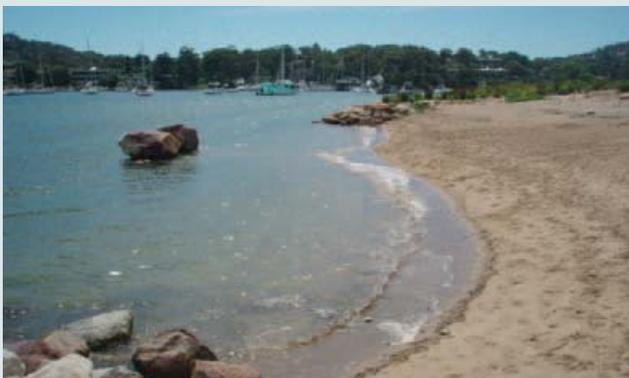
Figure 8: Bench of saltmarsh within seawall (top); Riparian vegetation behind the seawall to maximise habitat diversity (middle); Beach for foreshore access showing boulders used to create a small offshore reef (bottom).

- Around 4500 plant species from a range of endemic species planted, including saltmarsh grown from local provenance seeds and mangrove seedlings sourced from an adjacent established mangrove community (Figure 8).

- Modifications to the original design included a fence to exclude public and dog access to the revetment, several large boulders placed midway in front of the beach as a small offshore reef to dissipate wave energy and reduce any potential minor beach erosion (Figure 8), as well as treatment of potential acid sulphate soils followed by burial behind the seawall.
