CASE STUDY

Scott's Point rock fillets – fish friendly erosion mitigation

Authors: Charlotte Jenkins, Kylie Russell, NSW Department of Primary Industries (Fisheries)

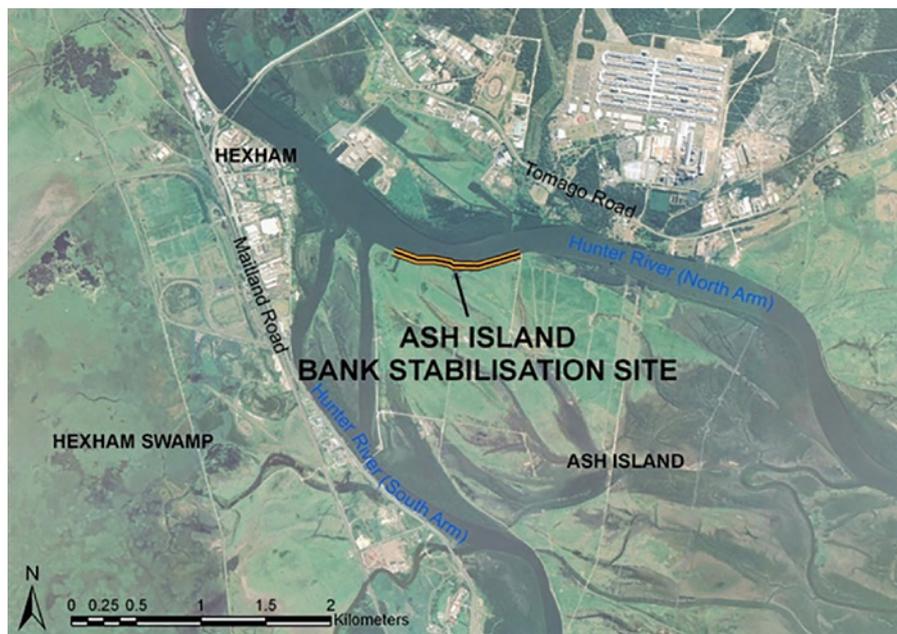
Figure 1. Aerial image of the project site at Ash Island.
Source: Google Earth.

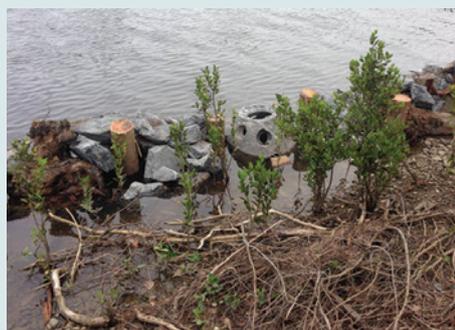
Inset: Rock fillets incorporating timber pins and concrete reef balls installed in the Bellinger River estuary, mid north coast NSW.
